EdgeStar IB450SS Ice Maker Power Switch Connection Fix

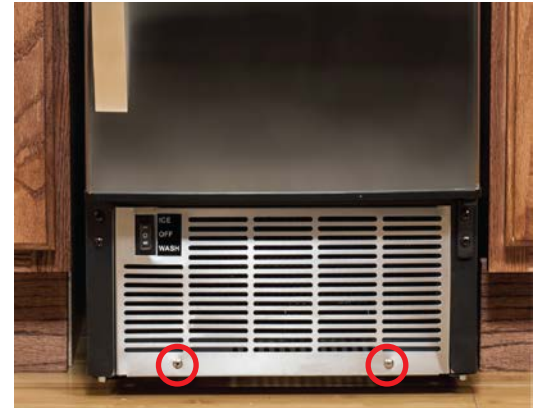
Step 1: Remove lower front kick plate / grill

Using a Phillips head screwdriver, remove the 2 screws (circled in red) that secure the bottom of the kickplate/grill to the ice maker cabinet.

Once the screws are removed, you will be able to swing the kickplate upwards and removed as needed from the 2 connector tabs at the top of top of the grill.

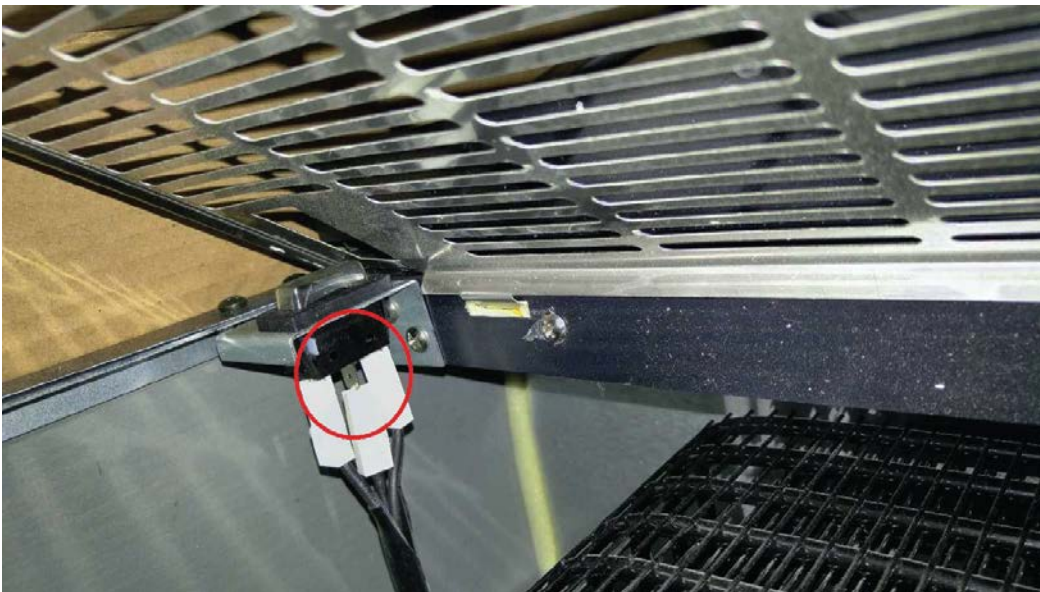
Step 2: Check wire connectors

With the kickplate swung upwards or completely removed to reveal the backside of the power switch (circled in red below), check the 3 wire connectors that attach to the power switch. Re-secure any loose or disconnected wires.

Reattach the kickplate/grill and secure in place using 2 Phillips head screws . Plug the unit back into a power source and test to ensure the problem has been resolved.
